SUMMARY of Road Safety Audit REPORT

Road Safety Audit on the Flandreau Santee Sioux Reservation, South Dakota

Date: November 3, 2006

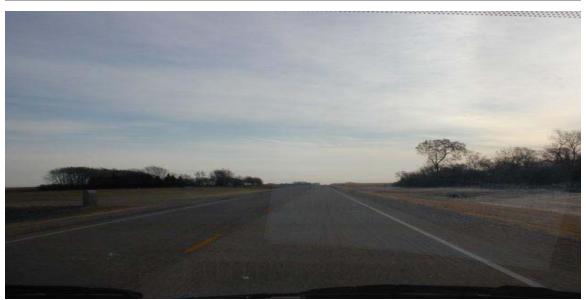
Figure 1: South Dakota Highway 32

The RSA Team examined several areas along the South Dakota Highway 32. The Team, however, did not find any major safety concerns or issues along this portion of roadway. In general, the South Dakota Highway 32 is a well-paved road with gentle slopes on the roadway edges. In addition, appropriate traffic signage is used throughout the roadway. A representative photograph of South Dakota Highway 32 is shown in Figure 1.

No specific suggestions were provided for South Dakota Highway 32.

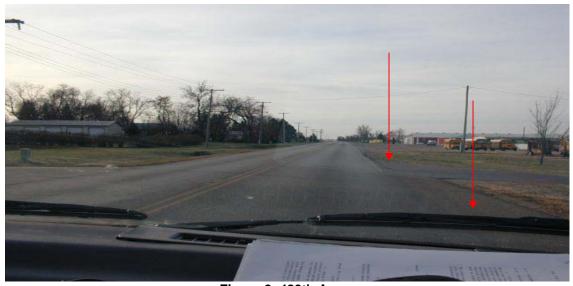
Figure 2: 480th Avenue

The RSA Team examined several areas along 480th Avenue. One of the key findings on this stretch of roadway was the narrowing of lanes. In some areas, the lanes would narrow unexpectedly and appropriate signage informing drivers of the lane changes was not available. A representative photograph of 480th Avenue is shown in Figure 2.

The RSA Team recommended that additional lane shift/narrowing signage be added along this portion of the roadway.

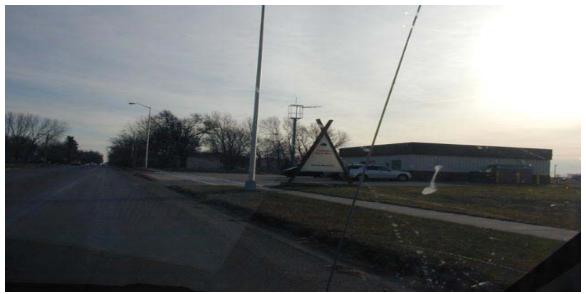
Figure 3: Broad Avenue

The RSA Team examined several areas along Broad Avenue and only found minor safety concerns. Near the intersection of Broad Avenue and the entrance to the Tribal Office, the RSA Team noted that there was a 4-way stop sign at a 3-way intersection. A representative photograph of Broad Avenue is shown in Figure 3.

Suggestion: The RSA Team recommended that the appropriate 3-way stop sign be implemented near the intersection of Broad Avenue and the entrance to the Tribal Office.

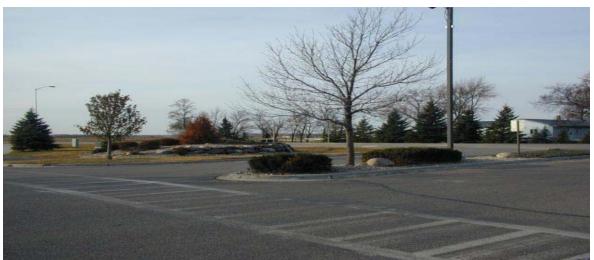
Figure 4: County 11th/480th Avenue

The RSA Team examined several areas along County 11th/480th Avenue. Near the west side of the Casino, the RSA Team noted that the stop sign ahead signage is completely faded and lacks the appropriate color. This may make it difficult for drivers to observe the stop sign during the nighttime or in inclement weather. In addition, some of the pedestrian walkway striping near the Casino appears faded or discolored. A representative photograph of County 11th/480th Avenue is shown in Figure 4.

Suggestion: The RSA Team recommended that all faded or outdated advance stop signs be removed or updated. The new stop signs should have the appropriate colors and retroreflectivity levels to ensure adequate visibility. In addition, all faded or outdated crosswalk striping along the County 11th/480th Avenue should be repainted or resurfaced.
